Occupational Safety and Health Administration

Inspection Number	1. Photo ID No.	2. Date/Time	3. Citation Number	4. Item Number	5. Instance No.
1148200	8835, 8848	5/18/2016	1	1	1

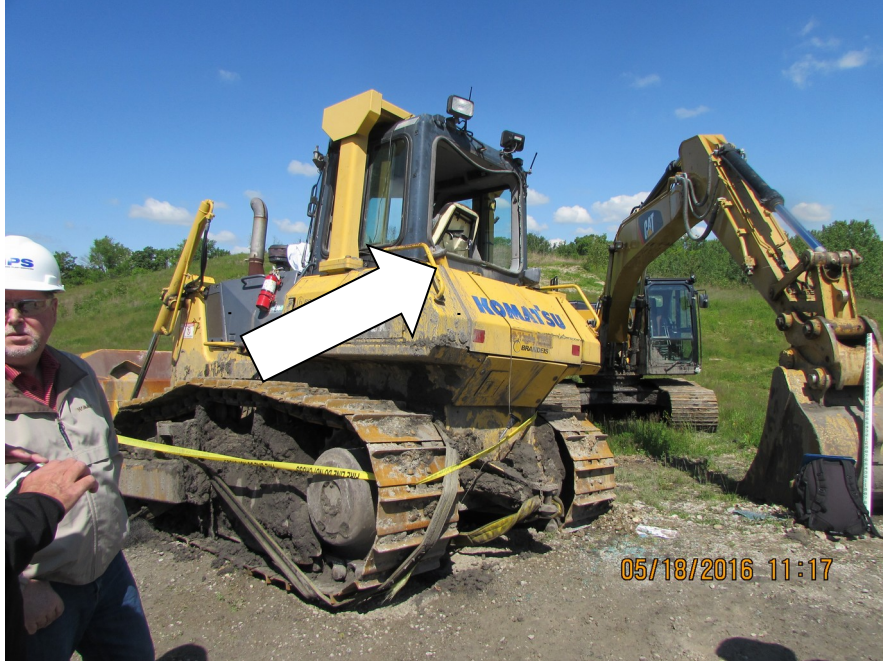
Note: Arrow is pointing to the rear window of the dozer where the impact of the strap/shackle struck the seat and the dozer operator.
